DELAWARE RIVER BASIN
TRIBUTARY TO PEQUEST RIVER
WARREN COUNTY, NEW JERSEY

**ALLAMUCHY
POND DAM
NJ 00501**

**PHASE 1 INSPECTION REPORT
NATIONAL DAM SAFETY PROGRAM**

**MARCH 1980
APPROVED FOR PUBLIC RELEASE;
DISTRIBUTION UNLIMITED**

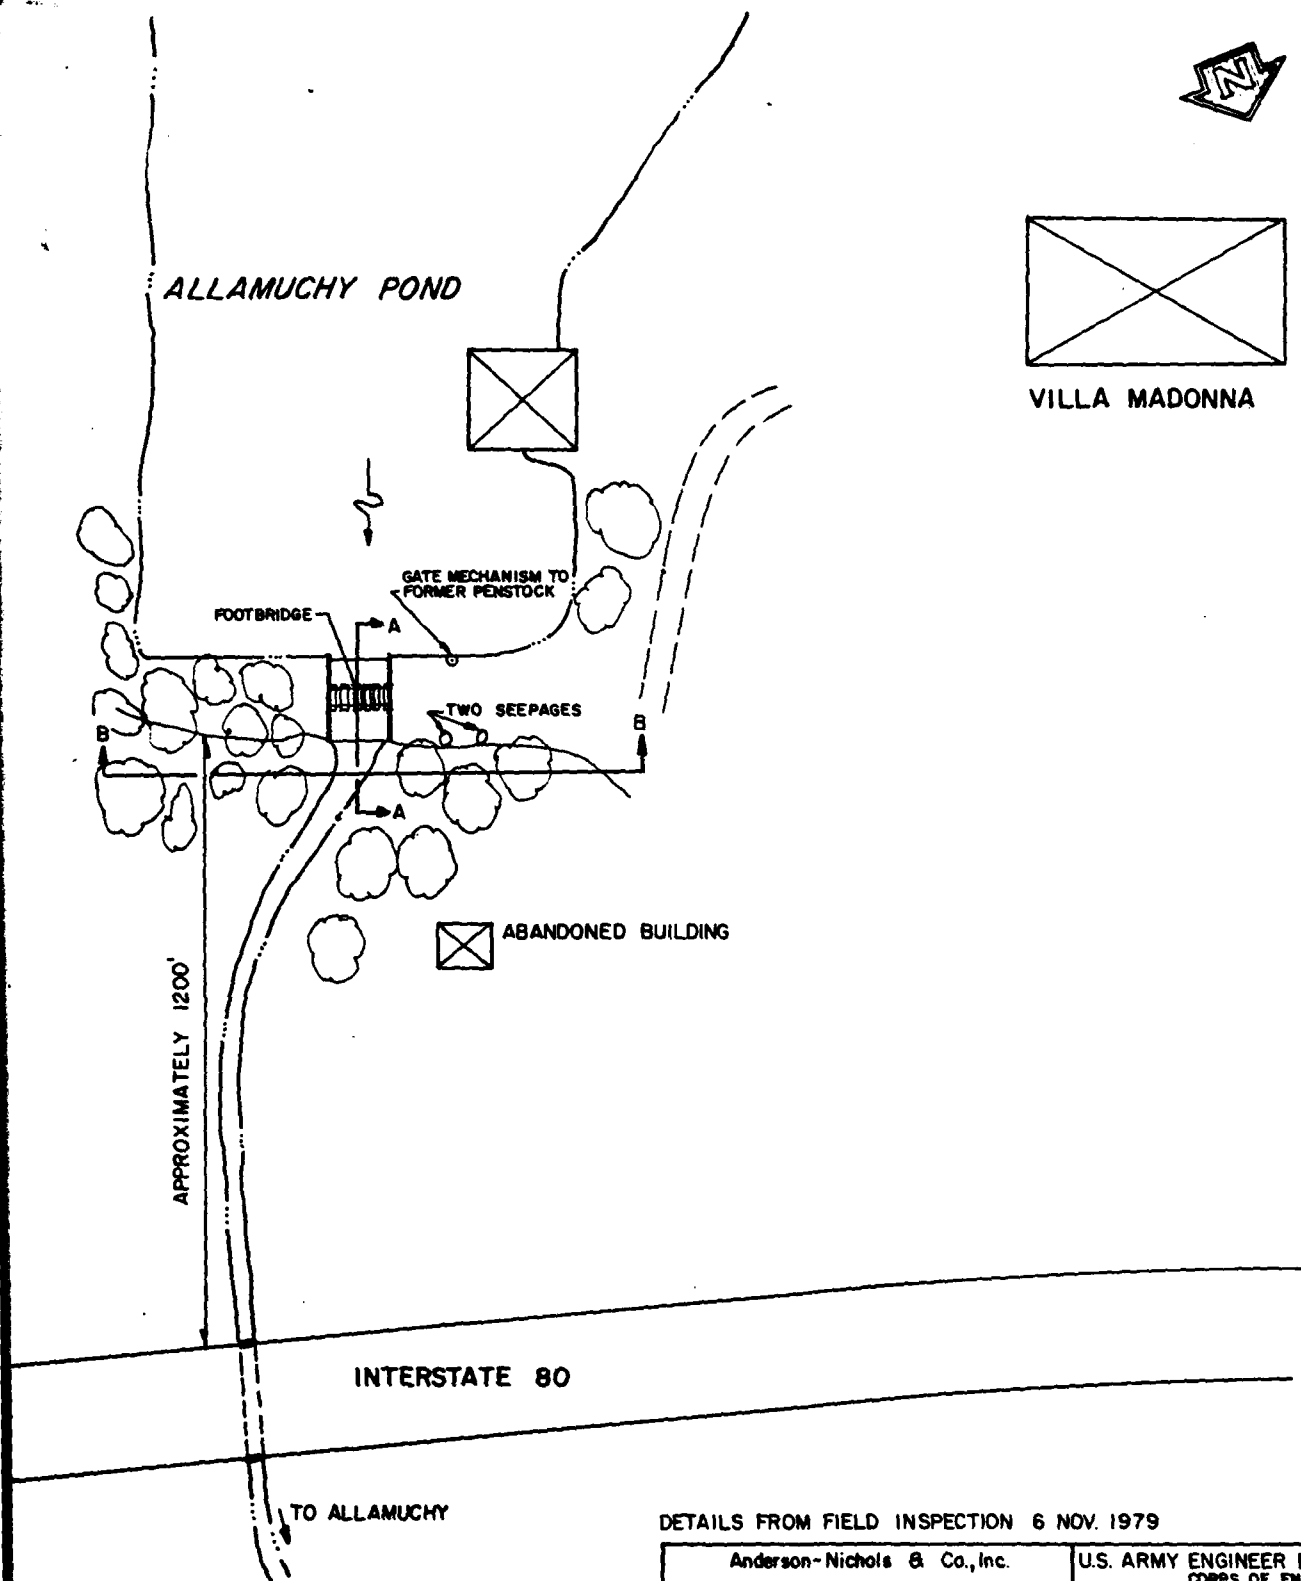
FIGURE 1

DETAILS FROM FIELD INSPECTION 6 NOV. 1979

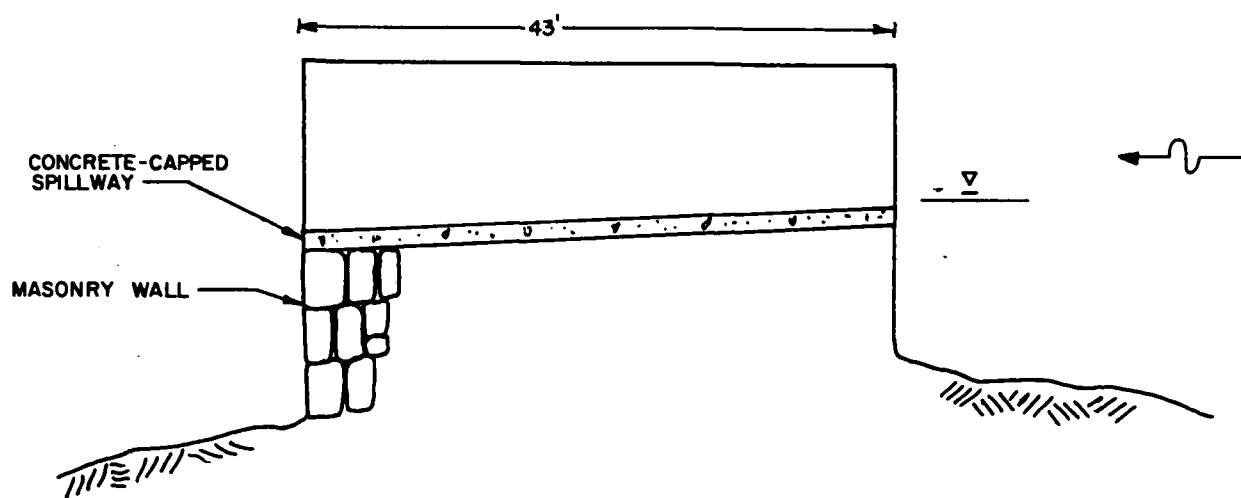
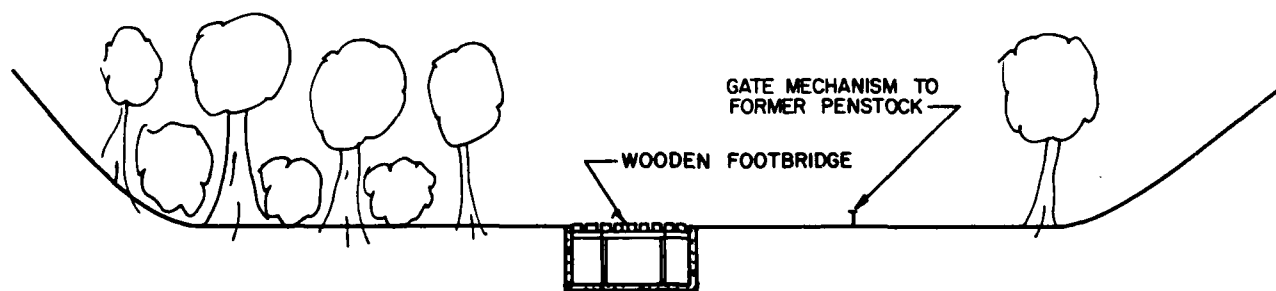
FIGURE 2

DETAILS FROM FIELD INSPECTION 6 NOV. 1979

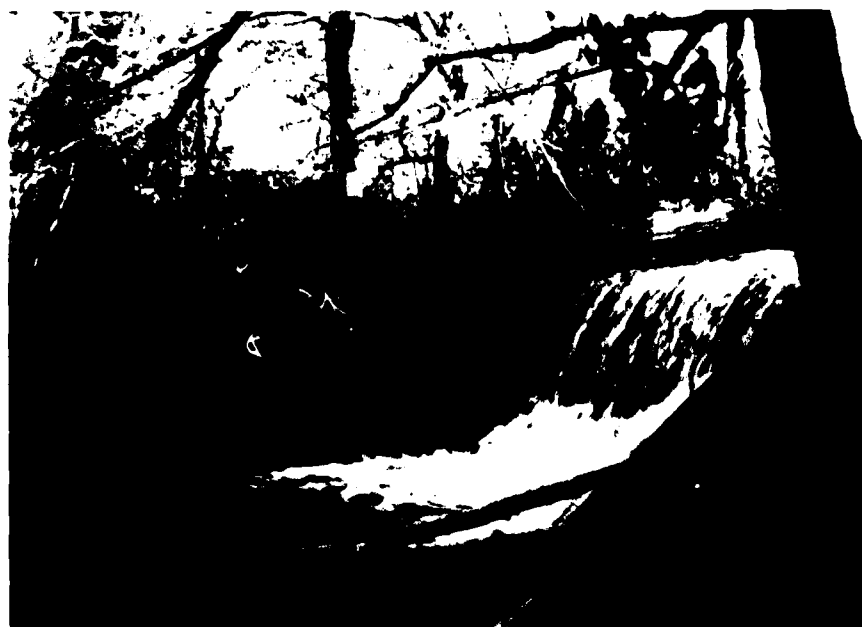
Continued spalling and cracking of the spillway apron and training walls could lead to piping and erosion if the water is allowed to pass through the concrete at the cracks and spalled areas.

5 NOVEMBER 1979
FROM WEST EDGE OF SPILLWAY DISCHARGE CHANNEL LOOKING AT THE
DOWNSTREAM FACE OF DAM AND SPILLWAY.

Repair cracked and deteriorated concrete on abutments and apron.
